École Varennes Building
Condition Assessment | June 6, 2022

Planning for the Future: The Next 5 Years

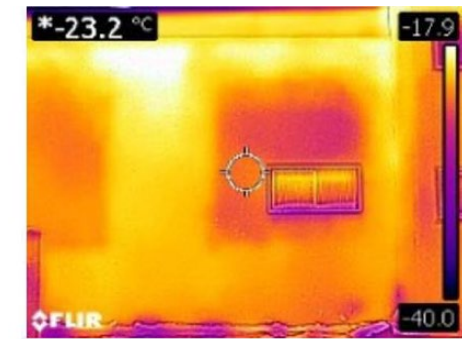
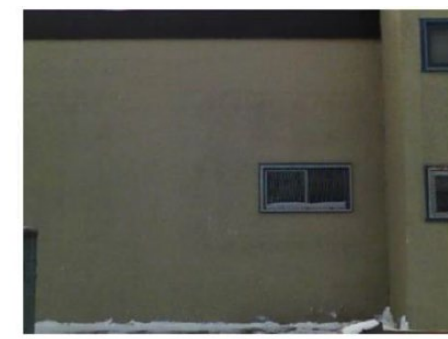
Camera	Date	Exterior Temp.	Interior Temp.	Spot Temp.	Emissivity
Fluke TiR32	2022-01-13	-12.6°C	20.0°C	VARIABLE	0.95

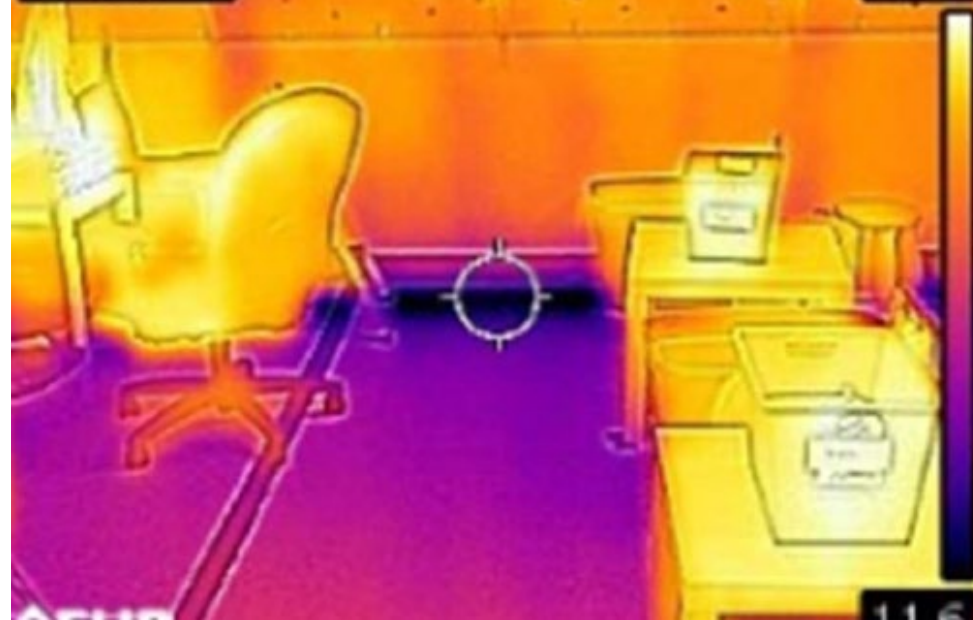
11.4 °C

19.6

- Inspect and address the exterior masonry wythe
- Reinforce the ladder truss masonry
- Upgrade air, moisture and thermal barriers of the building to meet the current code requirements including:
 - Address the potential water ingress issues with regards to the exterior stucco separation from windows and entrance masonry, non-compliant caulking at window frames, cracking of surface stucco layer due to lack of control joints in stucco, water ingress at grade level stucco-asphalt junction
 - Replace existing windows with fully-functioning new operable windows that provide continuity of the building envelope.
 - Address the air leakage and durability of the material components of the parapet and roof-exterior wall junction in the 1959 & 1977 Addition
 - Address thermal bridging issues and continuity of the thermal barrier at both grade and roof details across entire building

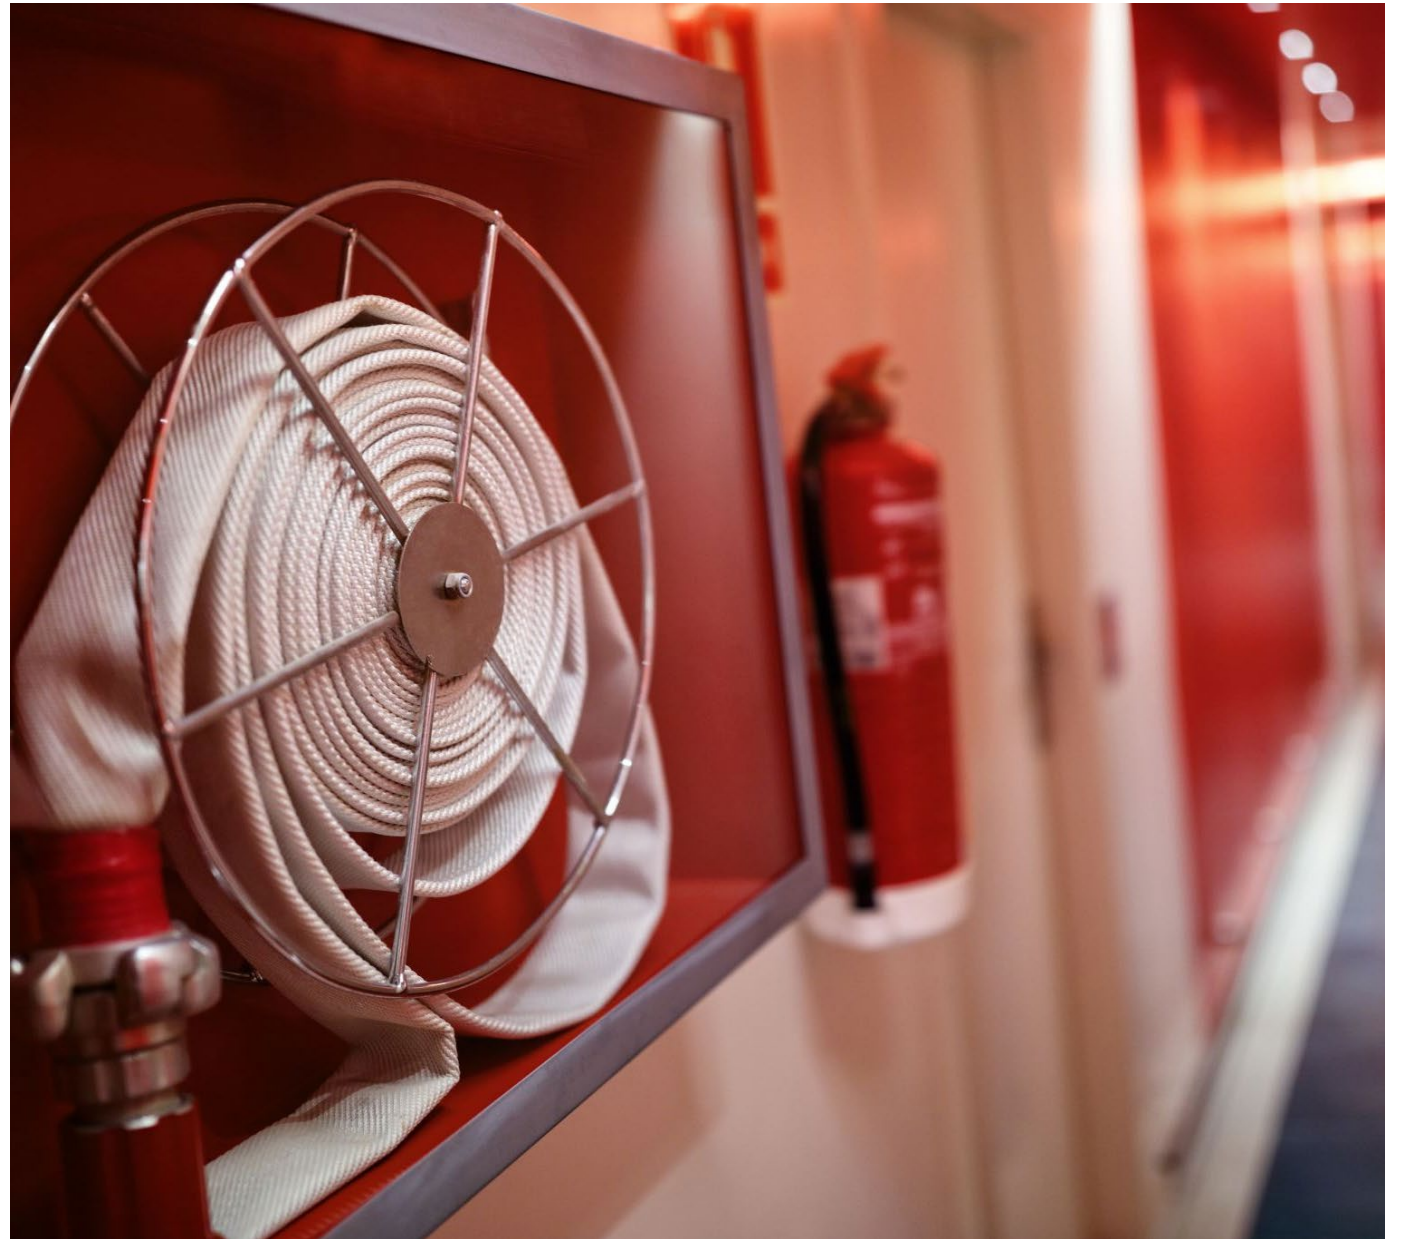
To meet current codes:

- Fire alarm monitoring must be replaced
- Pull stations need to be lowered
- Visual fire alarm indicators must be installed in all rooms

- All duplex receptacles should be replaced.
- Fire Alarm system should be replaced to meet current code requirements.
- Pull Stations to be installed at accessible height (not above 1200 mm).
- Existing exit lights should be replaced
- Emergency lights and battery banks should be replaced, and additional head should be installed
- Lighting throughout be upgraded to new energy efficient LED fixtures, complete with lighting control where applicable.

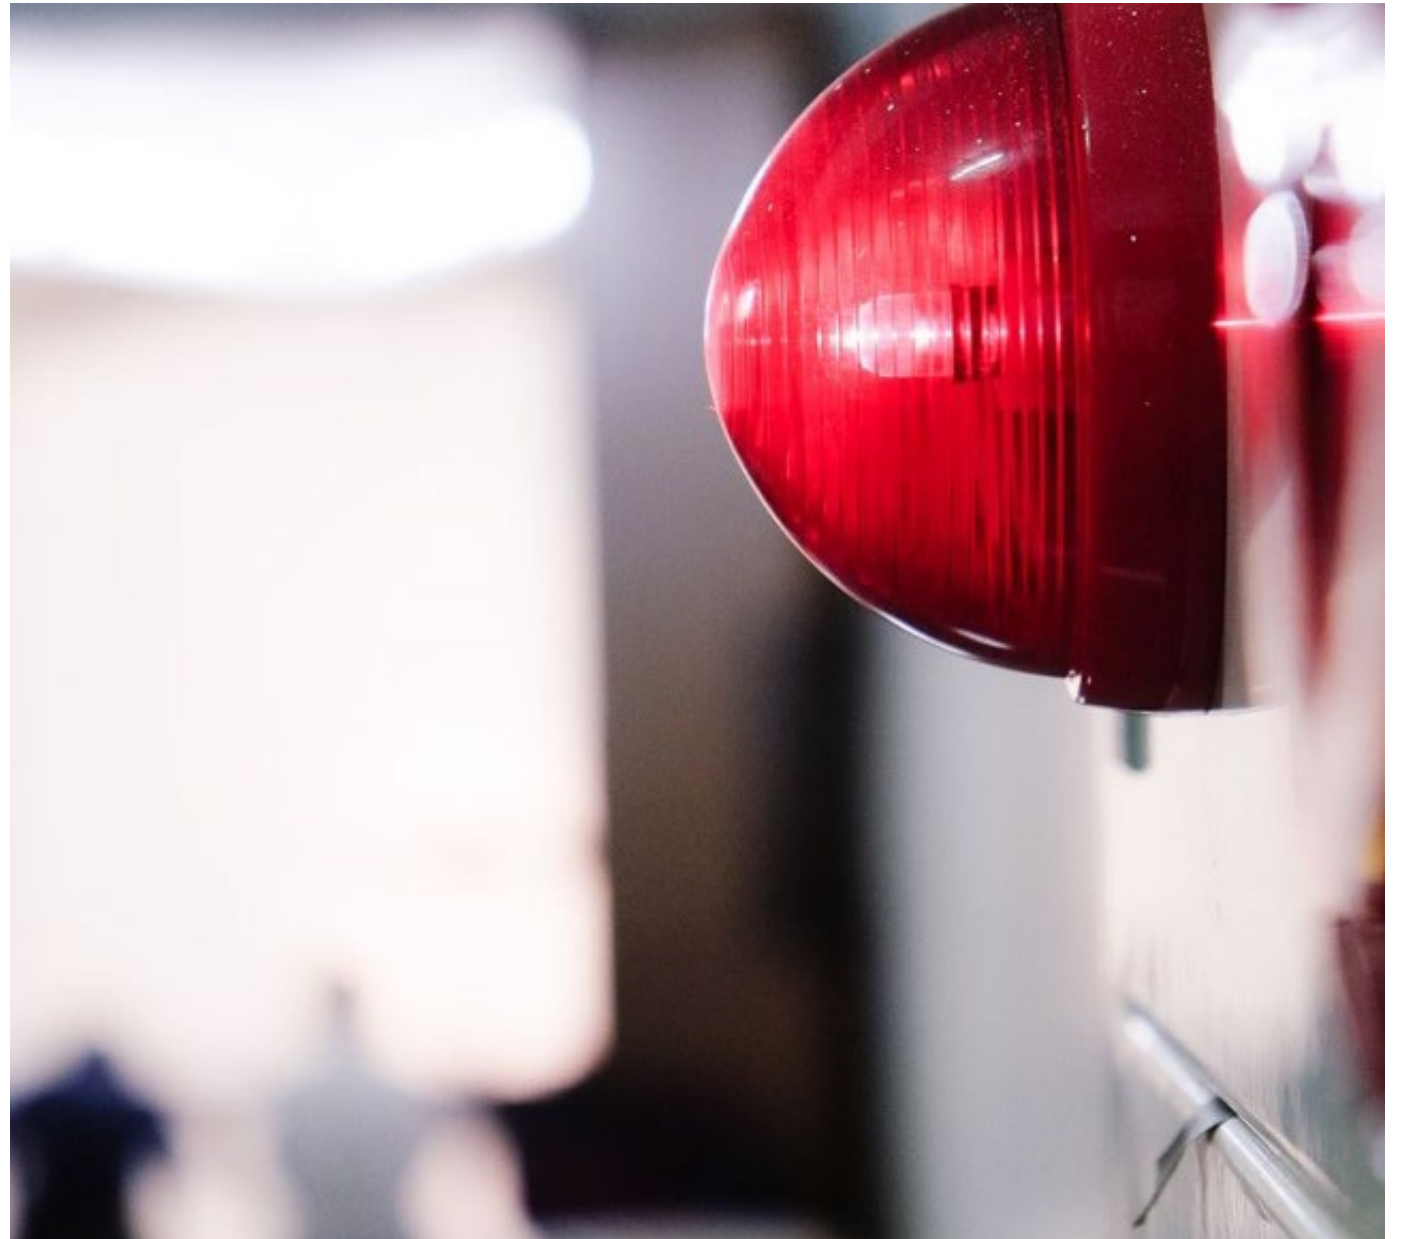
- Existing exit lights are operational but appear to be at the end of their life span and not all meet minimum code requirements.
- Majority of the battery banks for emergency lighting are antiquated and additional heads be installed.
