École Varennes Building
Condition Assessment | June 6, 2022

Planning for the Future: The Next 5 Years

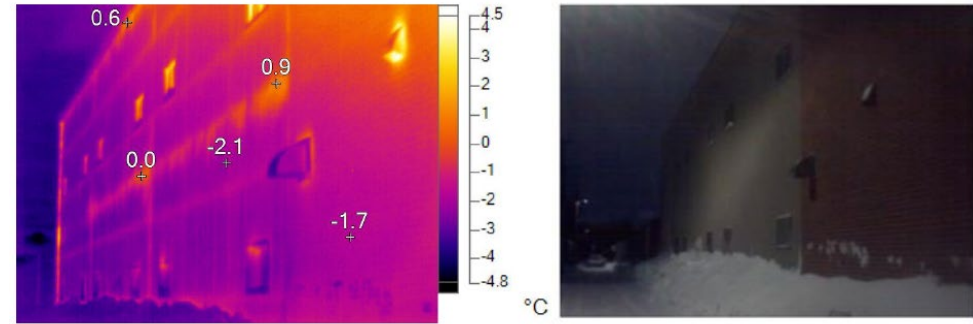
IR Image

Camera	Date	Exterior Temp.	Interior Temp.	Spot Temp.	Emissivity
Fluke TiR32	2022-01-13	-12.6°C	20.0°C	VARIABLE	0.95

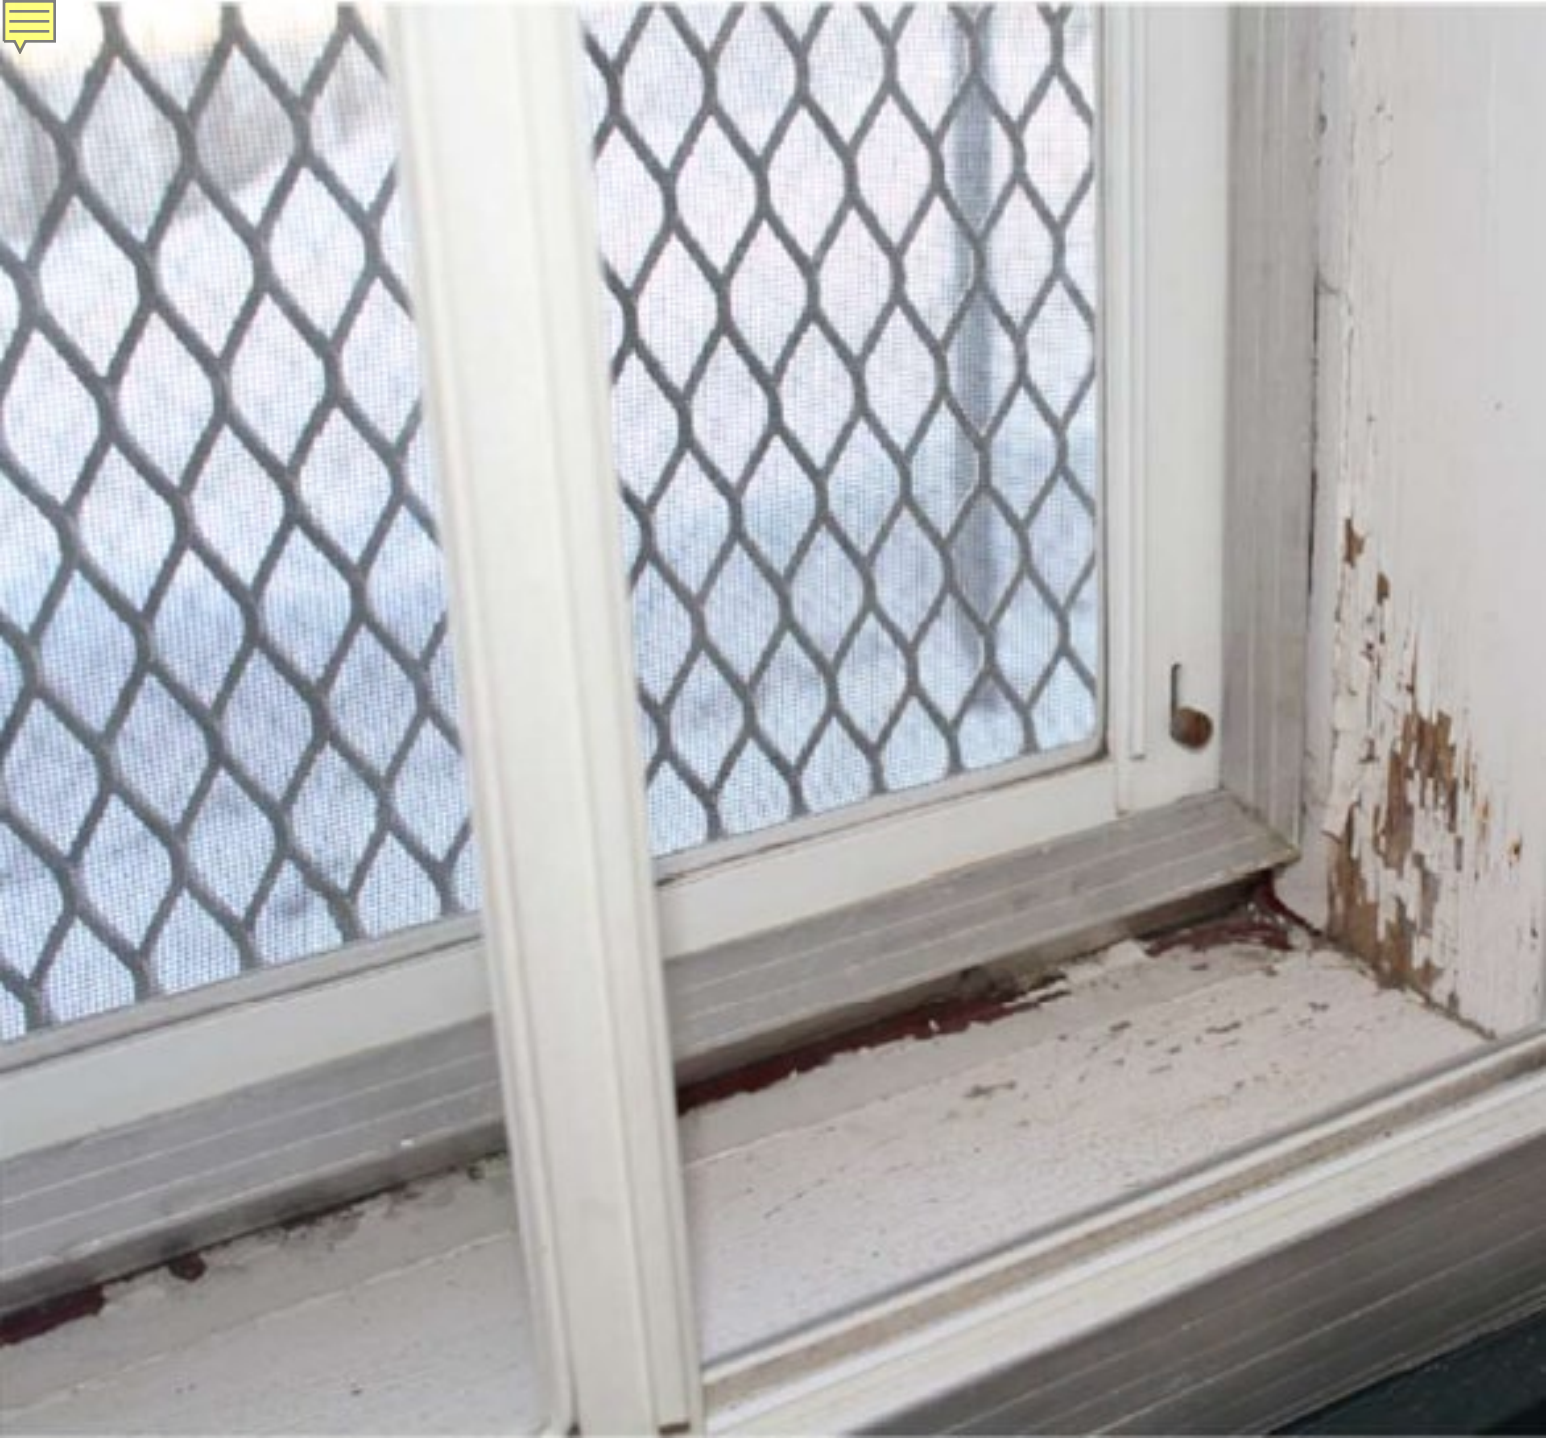
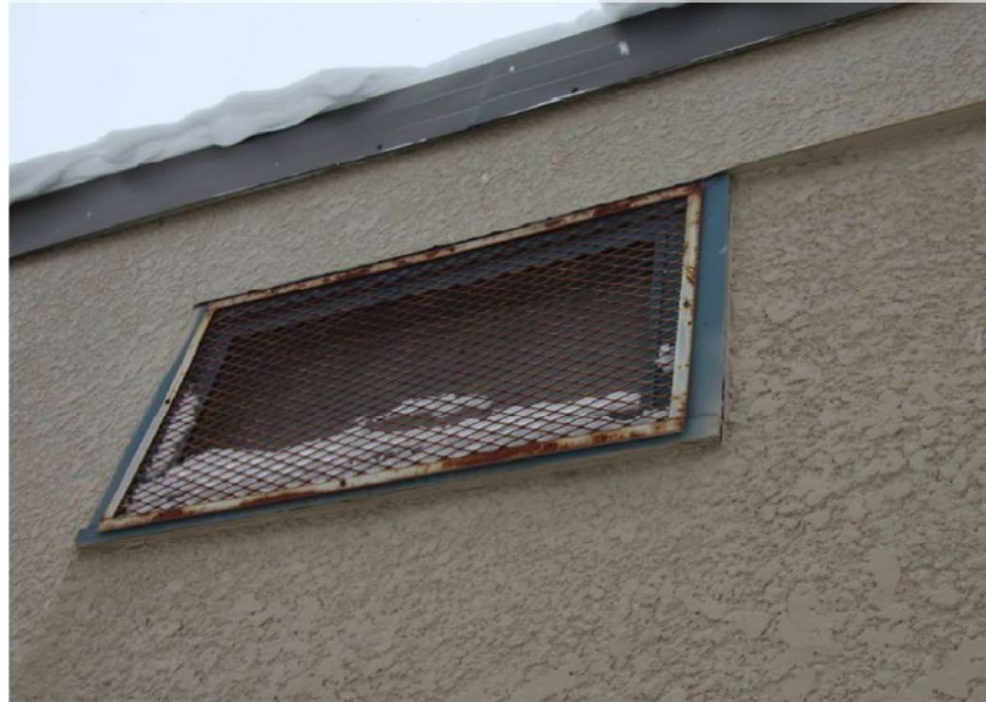
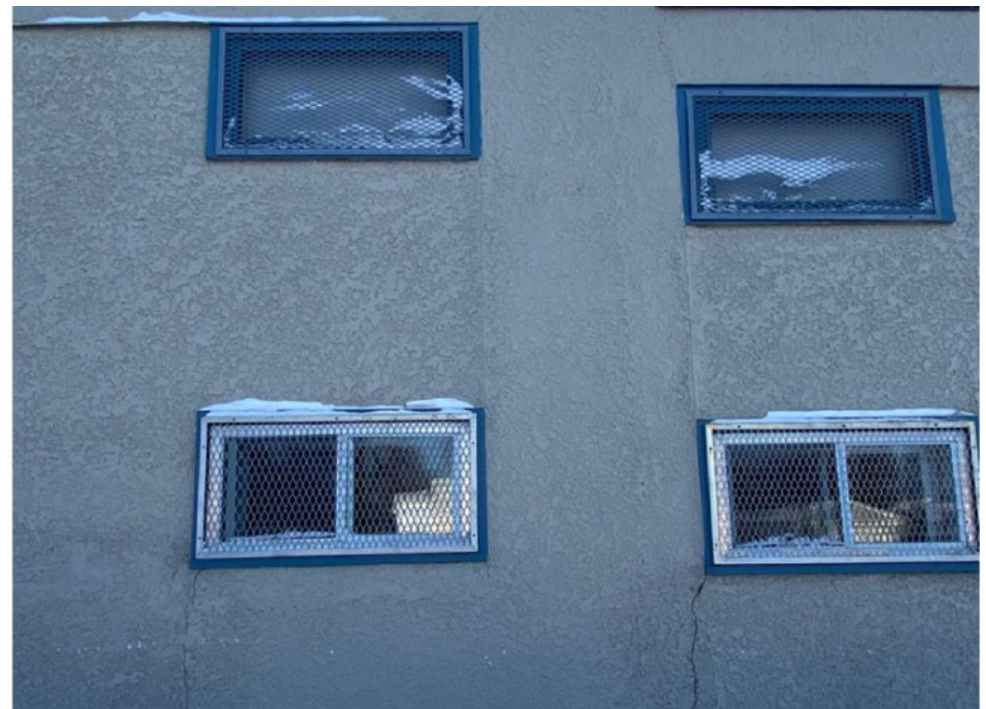
11.4 °C

19.6

- Inspect and address the exterior masonry wythe
- Reinforce the ladder truss masonry
- Upgrade air, moisture and thermal barriers of the building to meet the current code requirements including:
 - Address the potential water ingress issues with regards to the exterior stucco separation from windows and entrance masonry, non-compliant caulking at window frames, cracking of surface stucco layer due to lack of control joints in stucco, water ingress at grade level stucco-asphalt junction
 - Replace existing windows with fully-functioning new operable windows that provide continuity of the building envelope.
 - Address the air leakage and durability of the material components of the parapet and roof-exterior wall junction in the 1959 & 1977 Addition
 - Address thermal bridging issues and continuity of the thermal barrier at both grade and roof details across entire building
